Asbestos Register

St Killian

**6 Challis Avenue
Potts Point NSW 2011**

Strata Plan - 32735

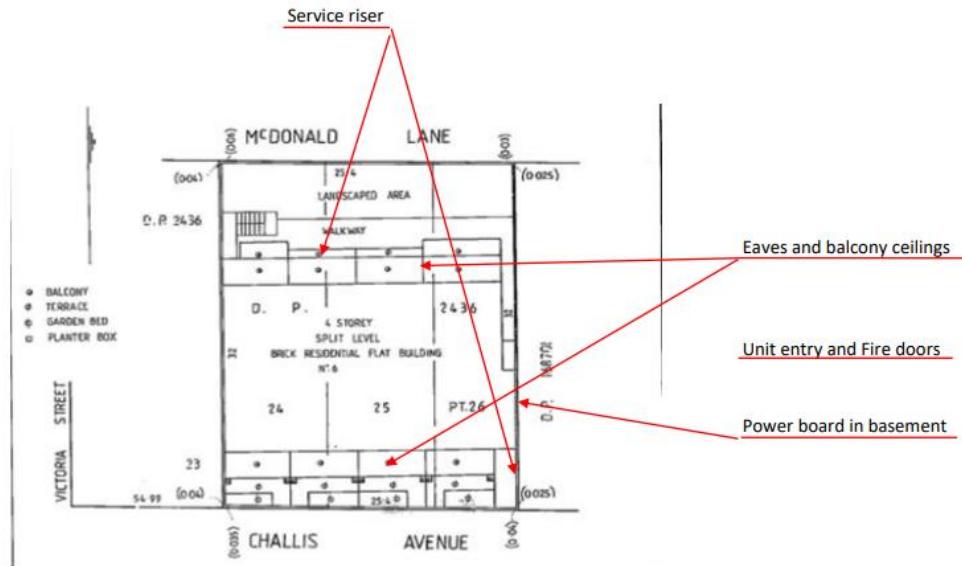
Asbestos Site Plan St Killian

SOLUTIONS IN ENGINEERING
ASBESTOS SURVEY FOR STRATA
6 Challis Avenue, Potts Point 2011
